Canon 7210 Fan Replacement

Replace the cooling fan in case of damage or malfunction.

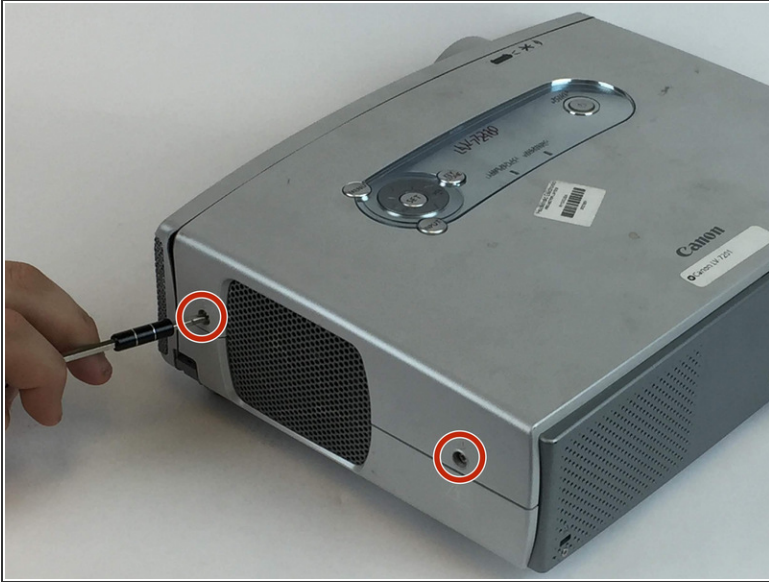
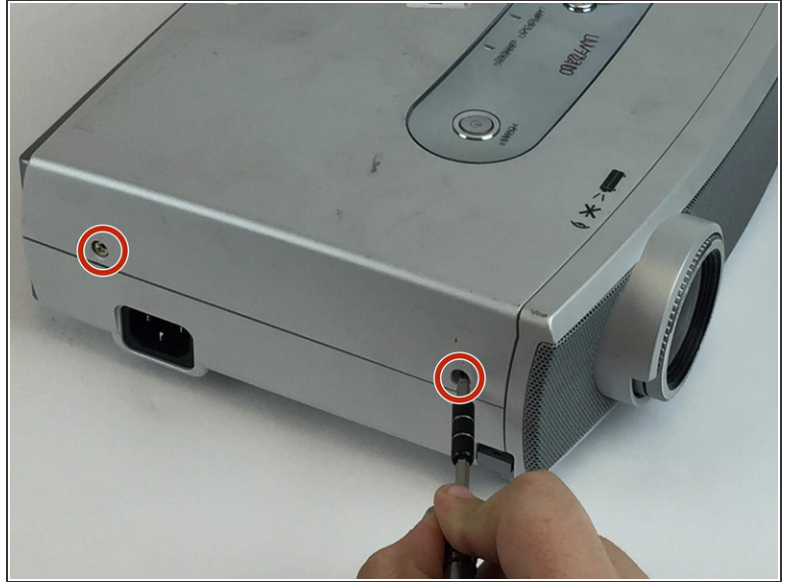
Step 1 — Exterior Shell

- Remove the 4 exterior 9mm Phillips #0 screws. They are located on the sides of the projector.

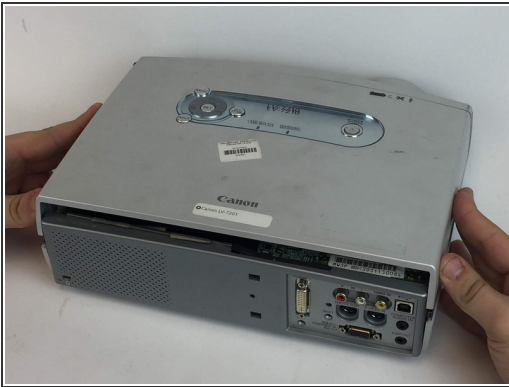
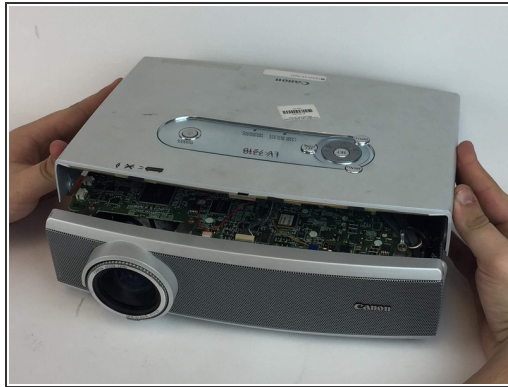
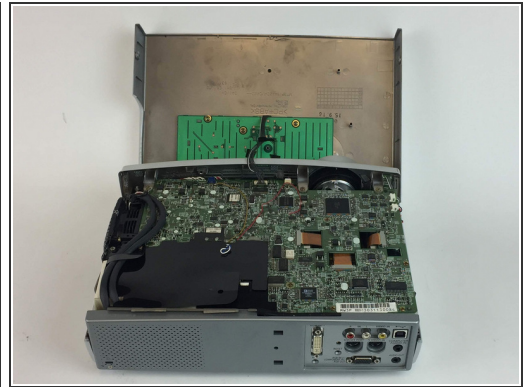
Step 2

- Gently lift up on the shell with both hands, from the back to the front.
- ⓘ The shell will still be attached by a small cord in the front, so be careful not to tear it loose.

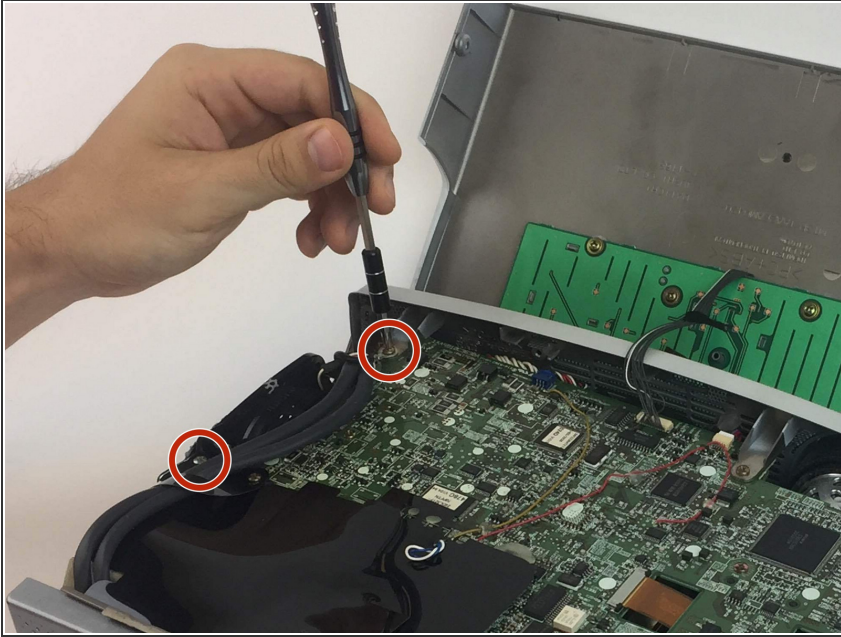
Step 3 — Fan

- Remove the two 7mm Phillips #0 screws that attach the fan to the motherboard of the projector.

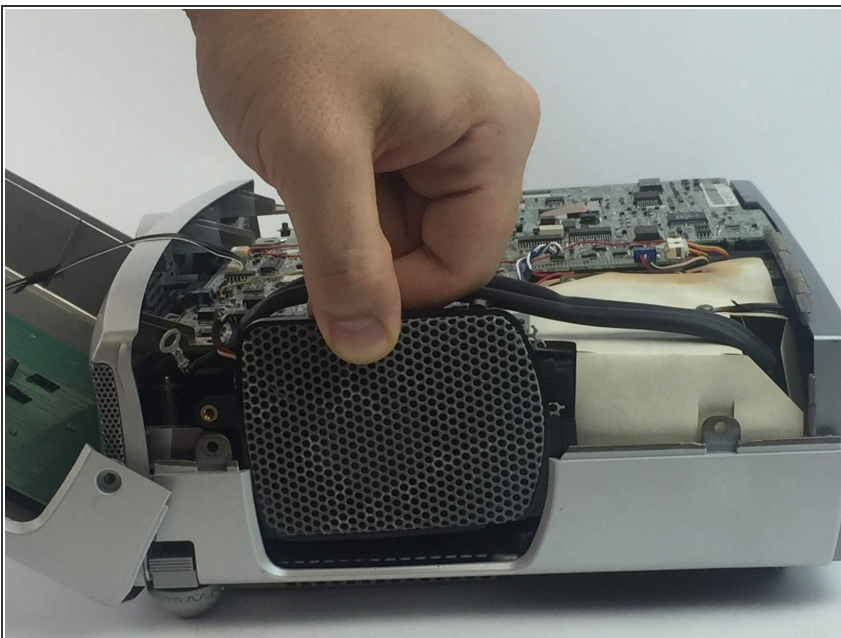
Step 4

- Remove the fan by pulling up gently from the top.
- ⓘ Be careful to not pull too hard or quickly, since the fan is still attached to the projector with some other wires.

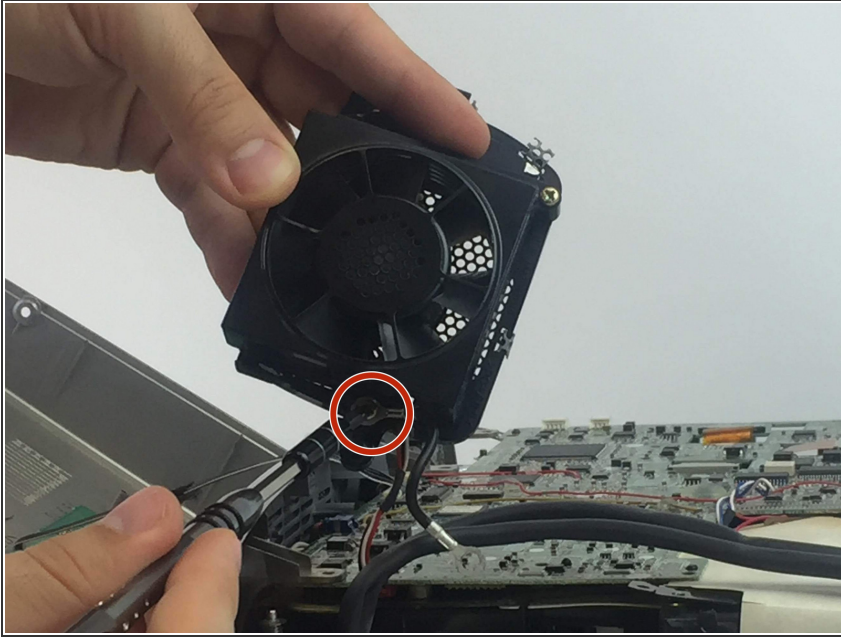
Step 5

- Remove the 7mm Phillips #0 screw that fastens the black ground wire connected to the fan and the projector.

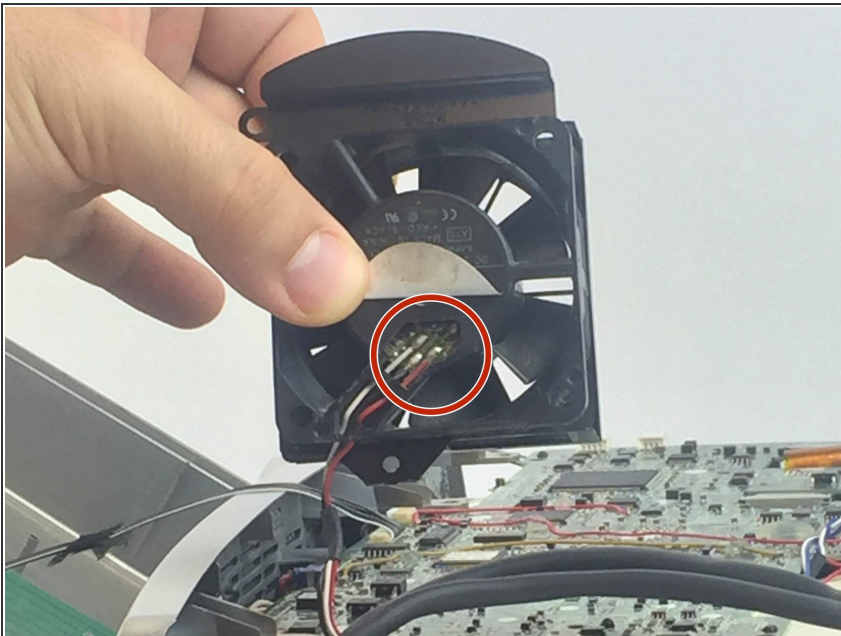
Step 6

- Peel the sticker up on the back of the fan to expose the port where the red, white, and black wires are attached.
- The wires will need to be cut with small wire cutters in order to completely remove the fan.
